SANDIA REPORT

SAND92-1611 • UC-404

MICROFICHE**Durability of Carbon-Plastic Electrodes
for Zinc/Bromine Storage Batteries**

Durability of Carbon-Plastic Electrodes for Zinc/Bromine Storage Batteries

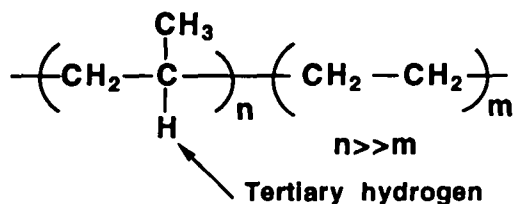
EP Copolymer

The lifetimes of zinc/bromine batteries may be limited by the durability of the thermoplastic components that are exposed to the bromine-containing electrolytes used in these batteries. One example of such a component is the bipolar carbon-plastic electrode. In early versions of the zinc/bromine battery, these electrodes were fabricated from copolymers of ethylene and propylene (EP copolymers). In previous durability studies, it was found that carbon-plastic electrodes made from propylene-rich EP copolymers warped during the operation of the battery, resulting ultimately in failure of the battery. Postmortem analyses revealed that the plastic component, namely the propylene-rich EP copolymer, had been oxidatively attacked by the electrolyte.¹ This chemical attack was believed to have exacerbated the warpage problem by enhancing the hydrophilicity of the electrode which, in turn, caused a higher degree of swelling. The susceptibility of EP copolymers to oxidative attack was attributed to the presence of a large number of tertiary hydrogens in the backbone of these polymers. The tertiary hydrogens occur at the branch points in the propylene units in the chain as shown below.

It is well known that such structures are vulnerable to thermoxidative degradation.² Improvements in oxidative stability should be made possible by eliminating most, if not all, of the tertiary hydrogens. This can be achieved by replacing the EP copolymer with an unbranched version of polyethylene, i.e., high-density polyethylene (HDPE). The simple structure of HDPE is shown as follows.

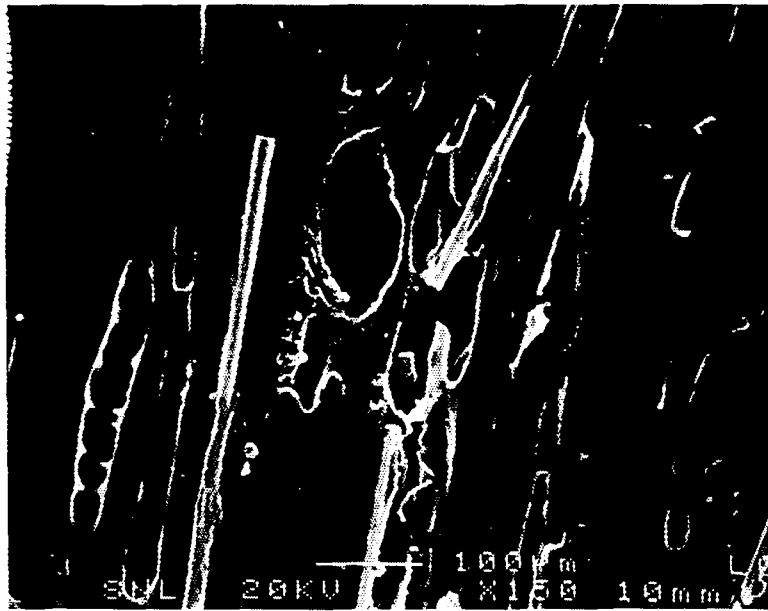
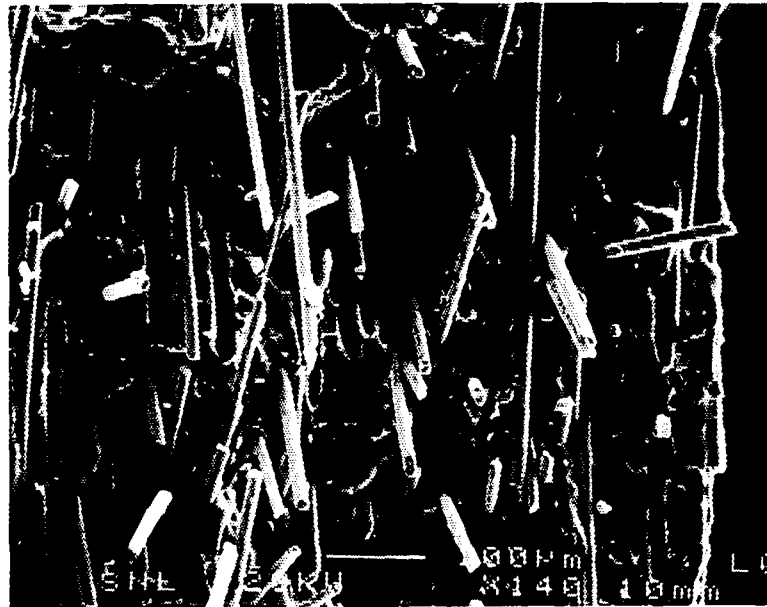
Figure 1. Scanning electron micrographs of HDPE-1. Upper photographs are opposite surfaces; lower photograph is the fracture surface.

Figures 1 and 2 show SEM photographs of HDPE-1 and HDPE-2, respectively. In each of these figures, the upper photographs are views of opposite surfaces of the electrodes and the bottom photograph is a view of the fracture surface across the thickness dimension of the electrode. It is apparent from these photographs that the fiber density on the surface of these electrodes was relatively low compared to that of the fracture surface. This accounts for the smooth texture at the surface of these electrodes. Most of the fibers appear to be oriented parallel to the surface of the electrodes. These orientation effects are probably related to the condition used to mold or extrude the electrodes.

In some of the earlier bipolar electrodes used in the zinc/bromine battery, a high-surface-area carbon coating was applied to one side of the electrode.³ When installed in the battery, this high-surface-area side of the electrode was in contact with catholyte and served to increase the kinetics of the bromine electrochemistry. There is no evidence from the SEM photographs that any such coating was applied to HDPE-1 or HDPE-2.

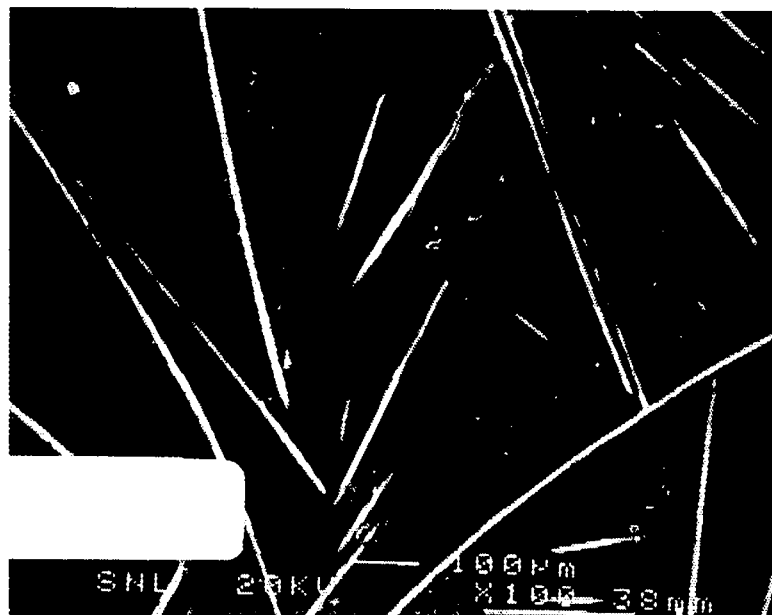
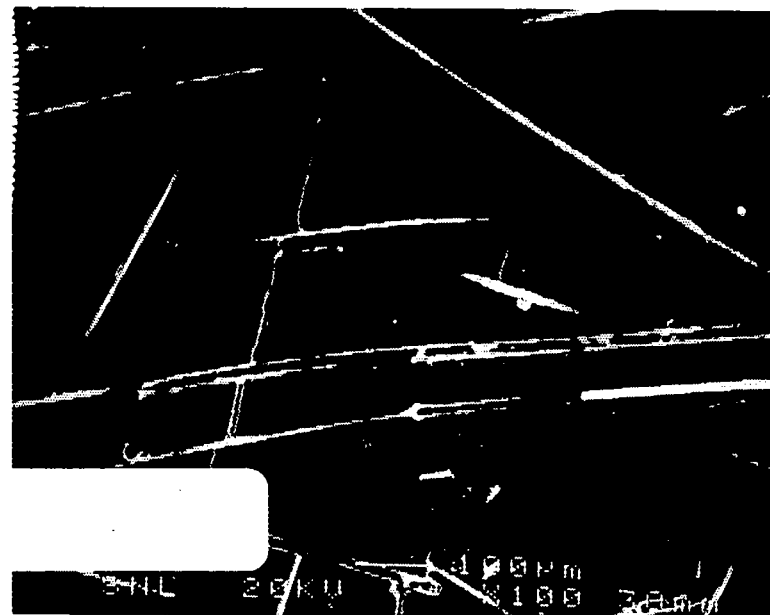
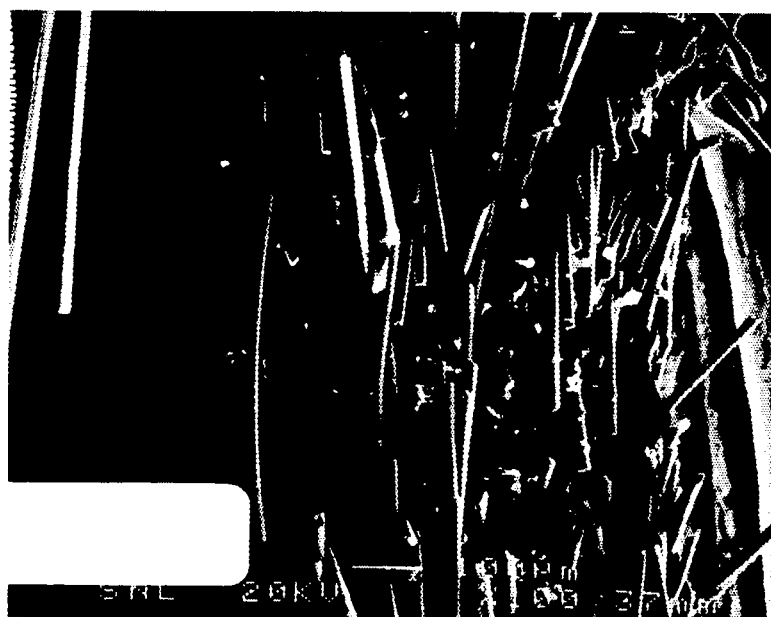
Figure 2. Scanning electron micrographs of HDPE-2. Upper photographs are opposite surfaces; lower photograph is the fracture surface.

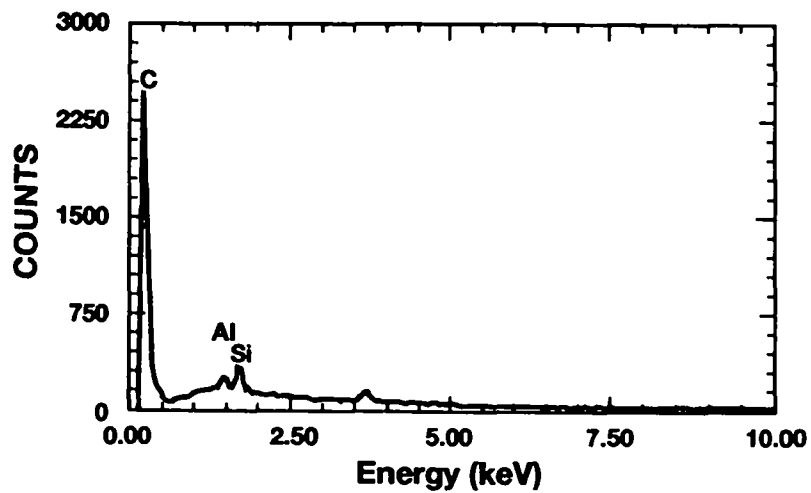
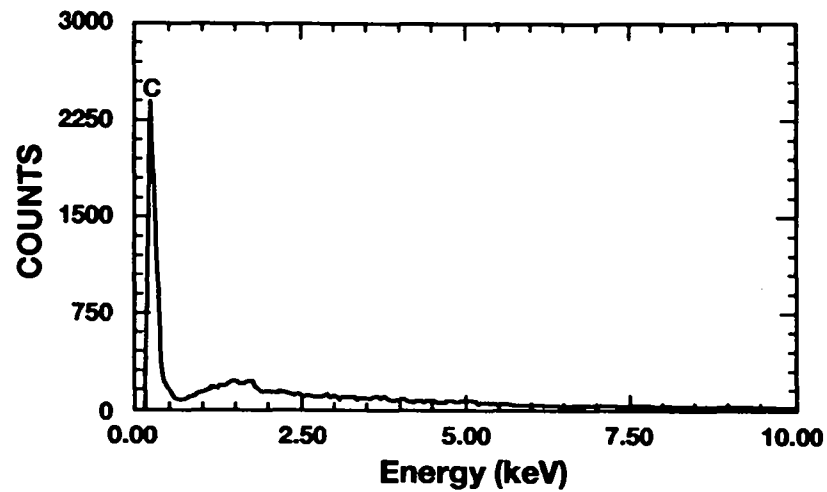
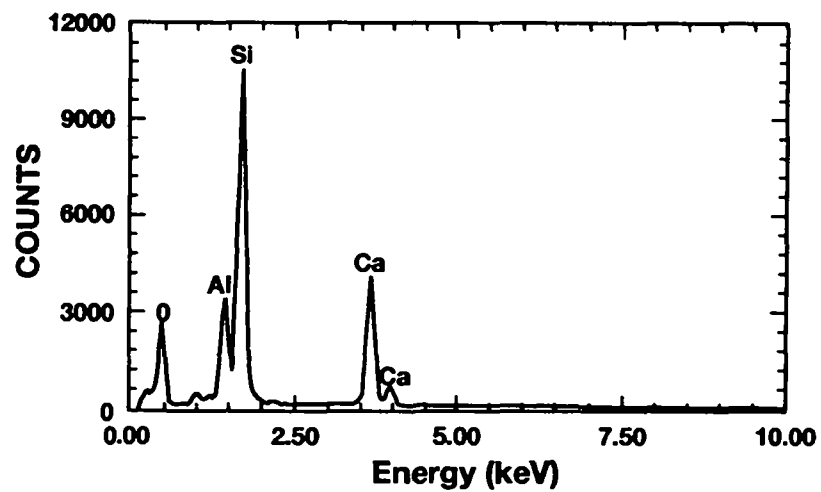
Figure 3. Elemental x-ray analyses of HDPE-1. Upper plots, carbon-plastic surfaces, show opposite sides; lower plot is the glass fiber on fracture surface.

Figures 3 and 4 show the results of x-ray analyses (EDAX) to determine the elemental composition of the carbon-plastic and glass-fiber portions of the electrodes. As expected, carbon was the predominant element detected in the smooth parts of the electrode, and the glass fibers were composed predominantly of oxygen, silicon, aluminum, and calcium.

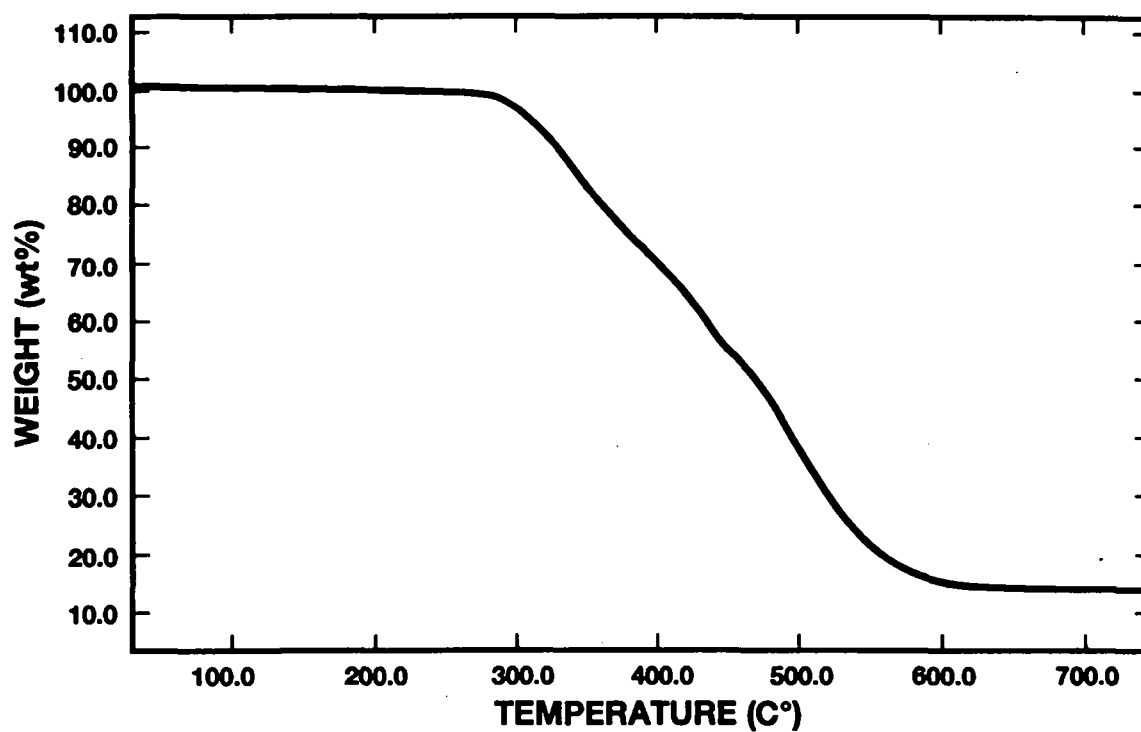
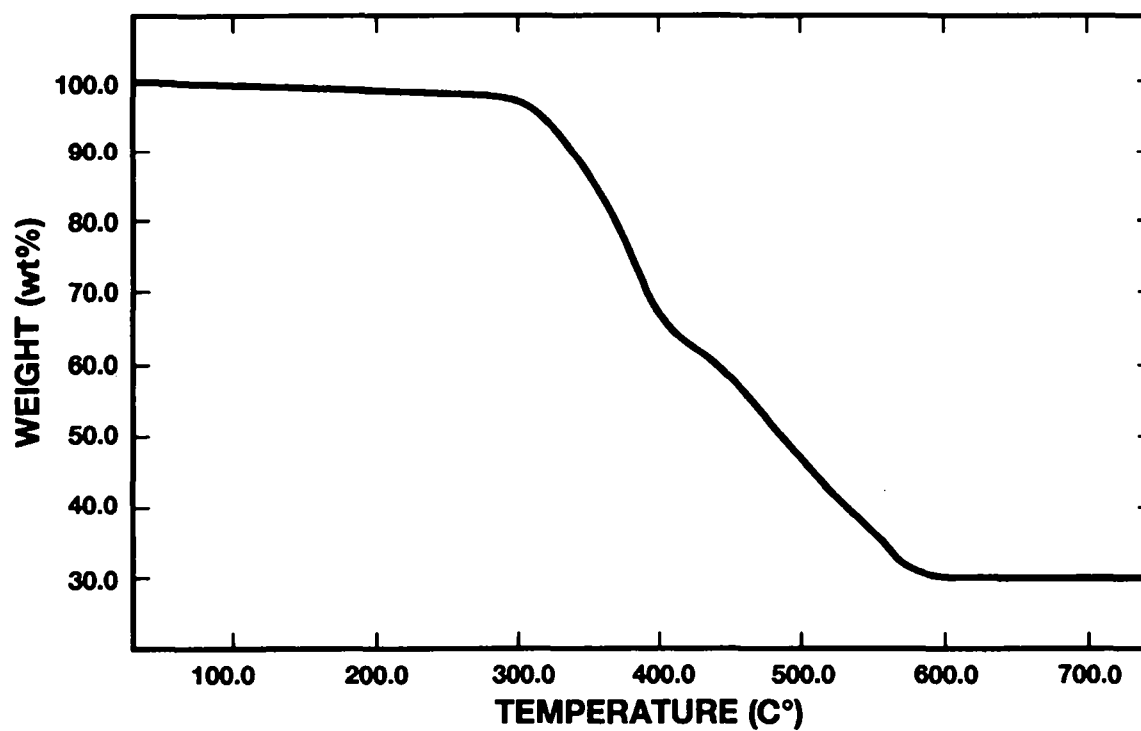
Figure 5. Thermogravimetric analyses performed in air at a heating rate of 20°C/min. Upper curve, HDPE-1; lower curve, HDPE-2.

Thermogravimetric analyses, shown in Figure 5, confirmed that HDPE-2 did in fact have a higher glass-fiber content than HDPE-1 (31% vs. 19%). In these analyses, all of the organic constituents of the

electrodes were removed by combustion, leaving only the glass fibers as a residue.

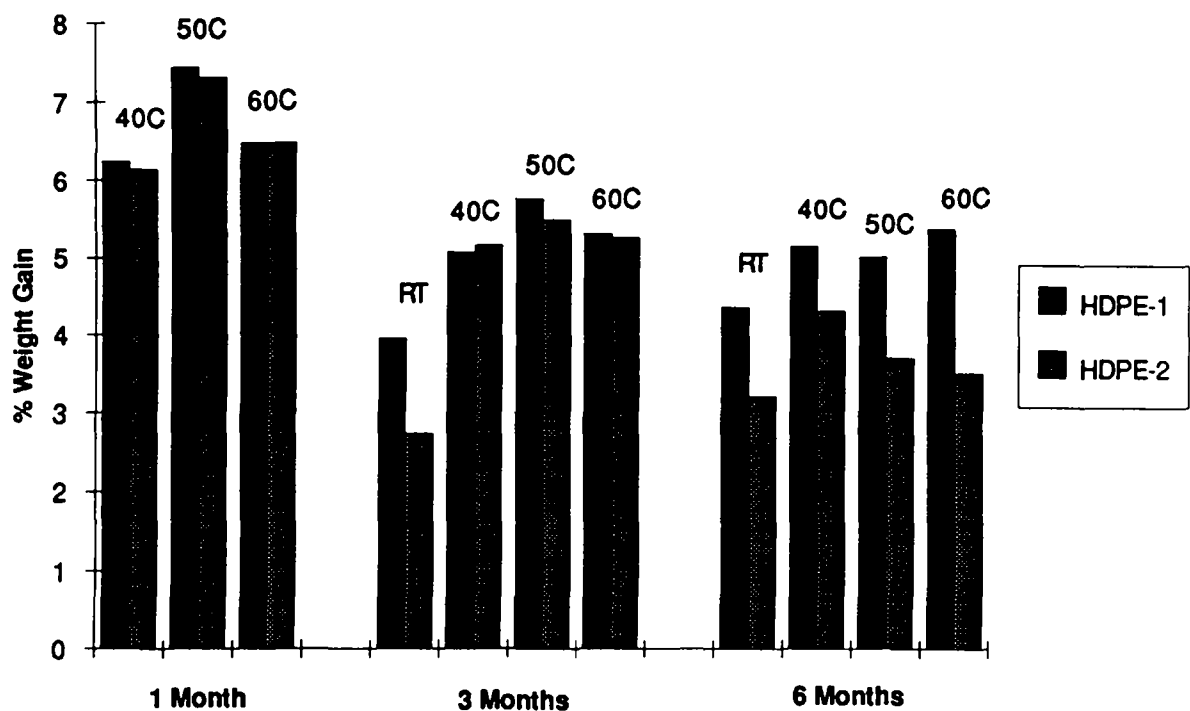
Figure 6. Column plot of percent sorption as a function of time and temperature for HDPE-1 and HDPE-2. Data represent weight gains after wiping off excess electrolyte and air-drying for 24 hours.

Sorption. Figure 6 is a column chart showing total weight gain as a function of time and temperature for HDPE-1 and HDPE-2. These data were obtained by measuring the increase in weight after removal of the excess electrolyte from the surface of electrode by wiping and air-drying for 24 hours. After 1 month of aging in the electrolyte, no differences in sorption between HDPE-1 and HDPE-2 were discernible. For both electrodes, weight gains were relatively high (6% to 7.5%) relative to weight gains observed after longer exposure times (3% to 5.5%). This decrease in sorption with time is not understood. One possible explanation is that equilibrium between the absorption and desorption processes had not been reached at the earlier time periods.

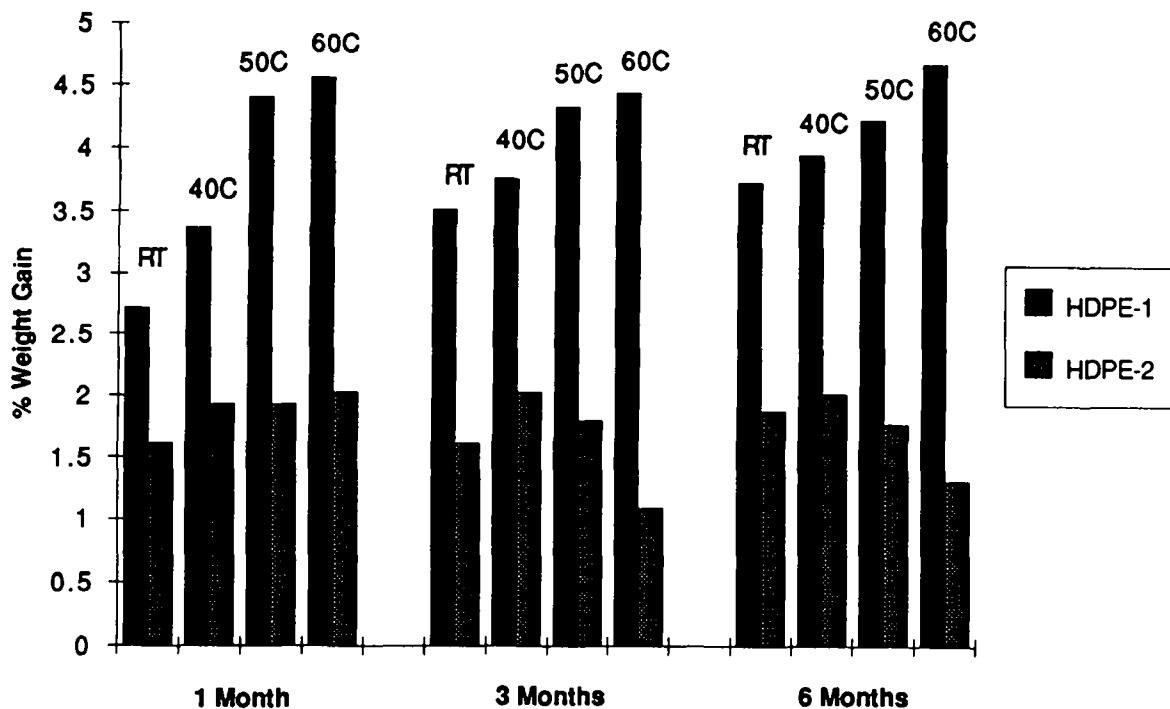
Figure 7. Column plot of percent sorption as a function of time and temperature for HDPE-1 and HDPE-2. Data represent weight gains after wiping off excess electrolyte and after washing to remove electrolyte salts and air-drying for 24 hours.

After 6 months of aging, differences in sorption between HDPE-1 and HDPE-2 became apparent (Figure 7). These differences in sorption were significantly larger after washing (4.5% for HDPE-1 vs. ~1.5% for HDPE-2). Washing with water removes all of the soluble electrolyte salts, such as ammonium chloride and zinc bromide. Since HDPE-2 has a higher glass-fiber content than HDPE-1, these results suggest that absorption of the non-ionic and/or hydrophobic components of the electrolyte occurs mainly in the carbon-plastic part of the electrode. These components were not identified.

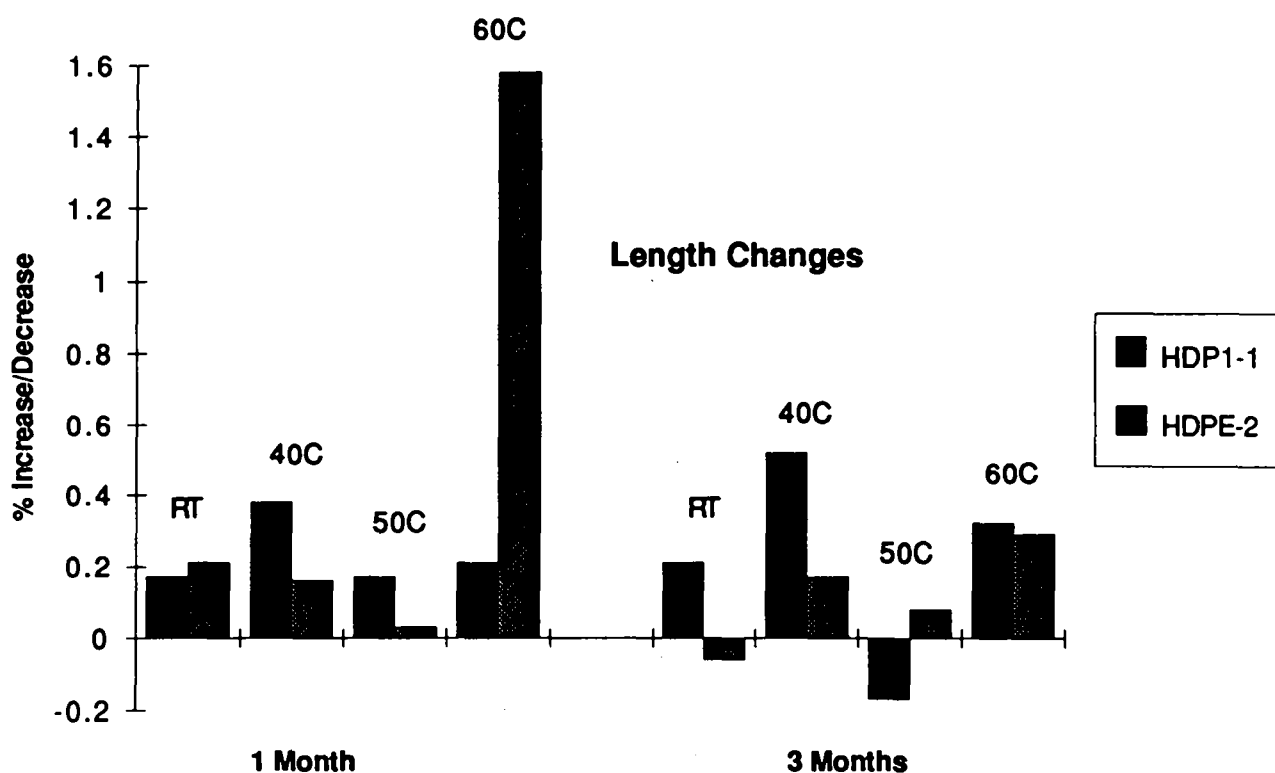
Figure 8. Column plot of percent changes in length as a function of time and temperature for HDPE-1 and HDPE-2. Dimensions were measured after a washing to remove excess electrolyte and after air-drying.

Dimensional Changes. Column charts depicting dimensional changes incurred by HDPE-1 and -2 as a result of accelerated and real-time aging are shown in Figures 8 through 10. The column magnitudes represent the average increase or decrease in length, width, or thickness for three samples. Despite considerable scatter in these data, the following general observations can be made:

1. With a few exceptions (RT/1 month, 60°C/1 month for length and 50°C/1 month for width), the percentage changes in length and width were less for HDPE-2 than for HDPE-1. Relative thickness increases, however, were higher for HDPE-2 at 60°C. The greater dimensional stability of HDPE-2 in the longer dimensions (i.e., length and width) is probably attributable to the higher glass-filler content of this electrode.

- On a percentage basis, the dimensional changes in thickness were greater than the dimensional changes in length and width for both electrodes. Thus, the following *ranges* of percentage changes for each dimension were: **thickness** (-1.5% to $+19\%$) $>$ **width** (-0.8% to $+1.7\%$) $>$ **length** (-0.13% to $+1.5\%$). The changes in length were skewed upward by one very high data point—namely, the 1-month 60°C point. If this data point is excluded, the range for length is reduced to 0.13% to 0.4% . On the basis of these data, one would expect that warpage would be less with HDPE-2, the electrode with the higher glass-fiber content. This expectation assumes that smaller percentage changes in the larger dimensions—namely, length and width—would have a greater detrimental effect on warpage than larger percentage changes in thickness.

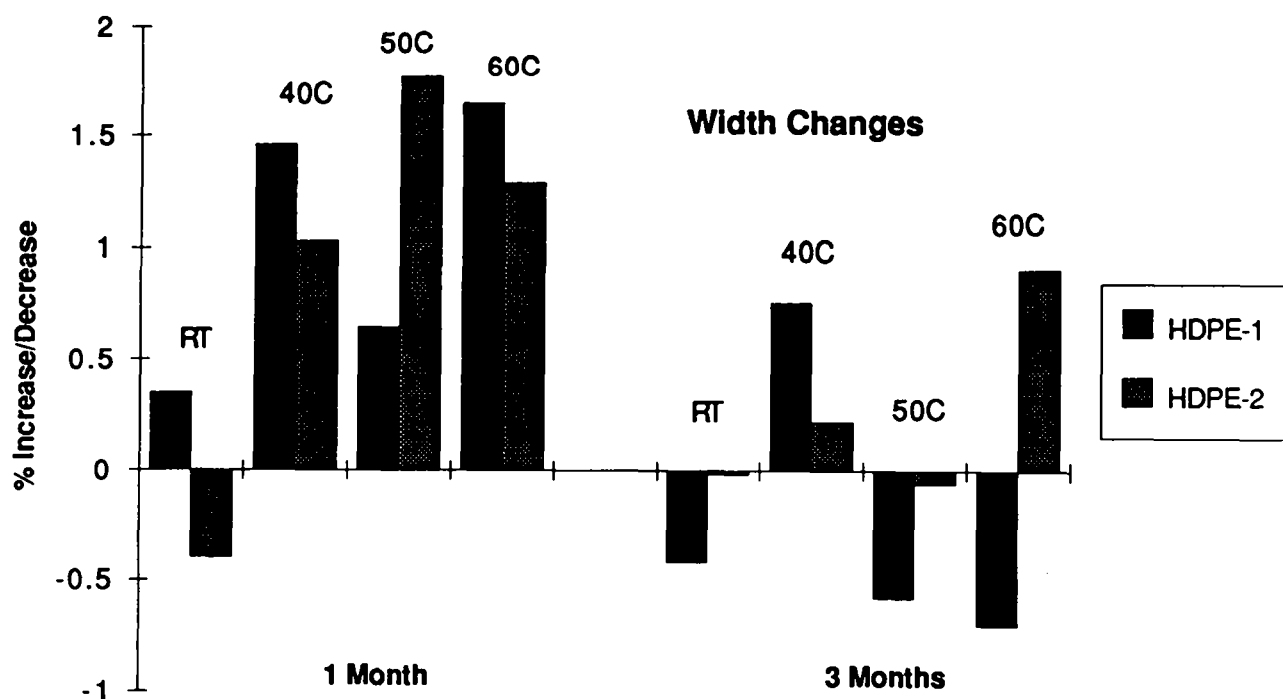
Figure 9. Column plot of percent changes in width as a function of time and temperature for HDPE-1 and HDPE-2. Dimensions were measured after a washing to remove excess electrolyte and after air-drying.

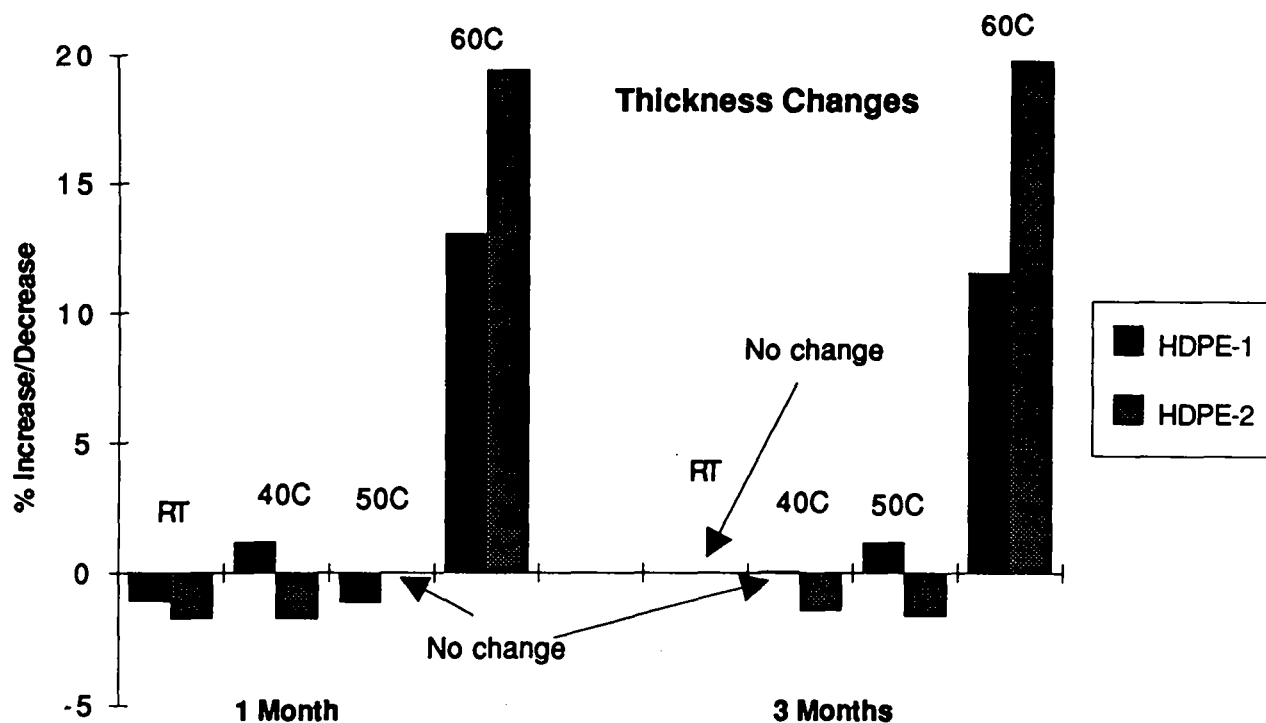
Figure 10. Column plot of percent changes in thickness as a function of time and temperature for HDPE-1 and HDPE-2. Dimensions were measured after a washing to remove excess electrolyte and after air-drying.

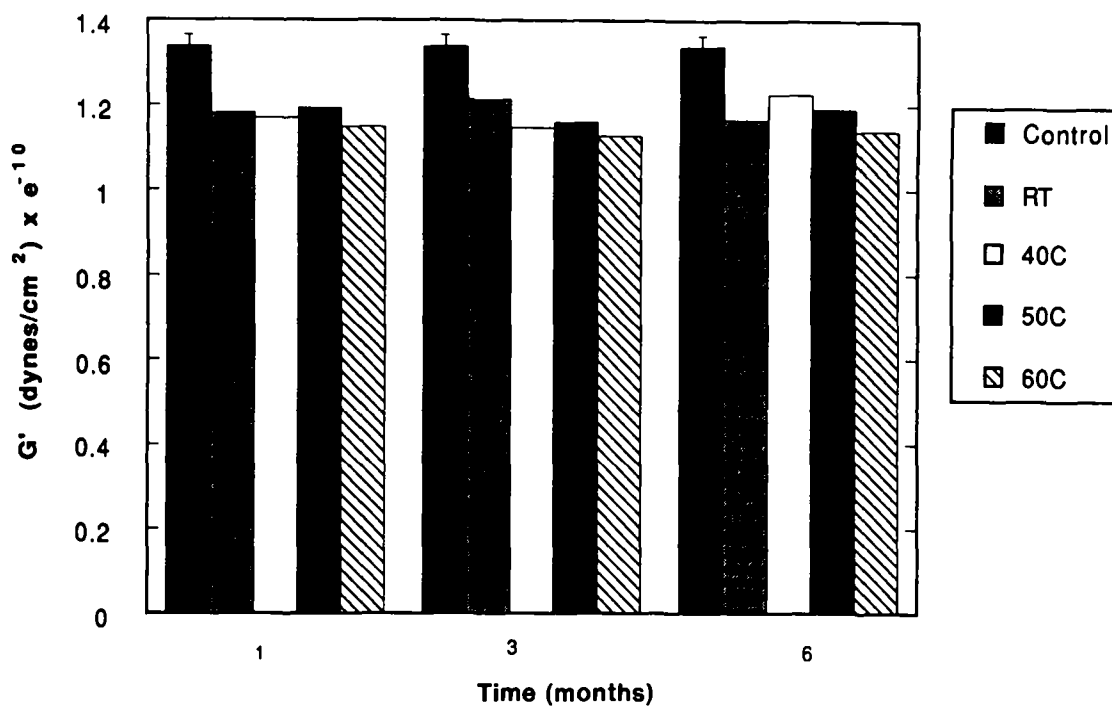
Figure 11. Column plot of the storage modulus (G') as a function of time and temperature for HDPE-1. Data obtained after washing to remove excess electrolyte and after air-drying.

Mechanical Characterization. The room temperature storage moduli (G') for HDPE-1 at all the aging conditions are summarized in Figure 11. The moduli decreased by about 10% at all aging conditions. This decrease in modulus appears to be real; the experimental error for these samples of HDPE-1 was only 2–3% and could be attributable to degradation or plasticization due to “permanent” sorption of some electrolyte components. If degradation was the primary cause for the decrease in modulus, one would expect to observe trends with time and temperature. That no such trends were observed suggests that degradation, if it occurred at all, was minimal.

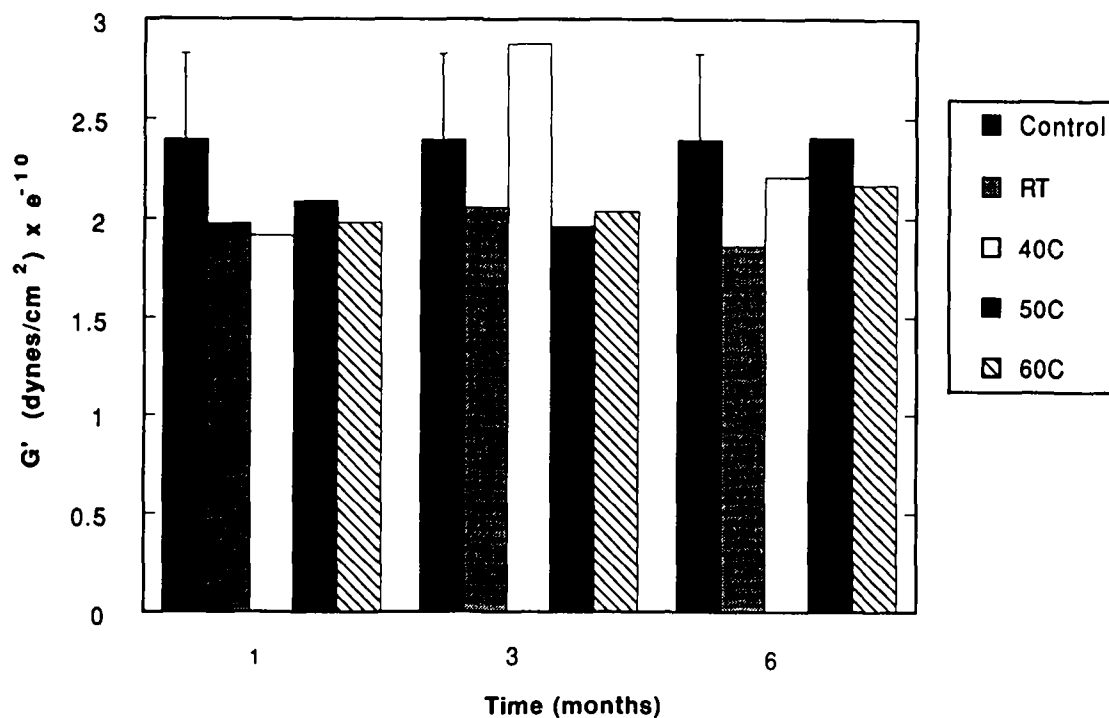
Figure 12. Column plot of the storage modulus (G') as a function of time and temperature for HDPE-2. Data obtained after washing to remove excess electrolyte and after air-drying.

As shown in Figure 12, similar results were obtained for HDPE-2, though for this electrode the spread in the data was much wider (sigmas for HDPE-2 were ~18% vs. 2–3% for HDPE-1). The larger data scatter observed for HDPE-2 may be attributable to greater heterogeneities in this electrode.

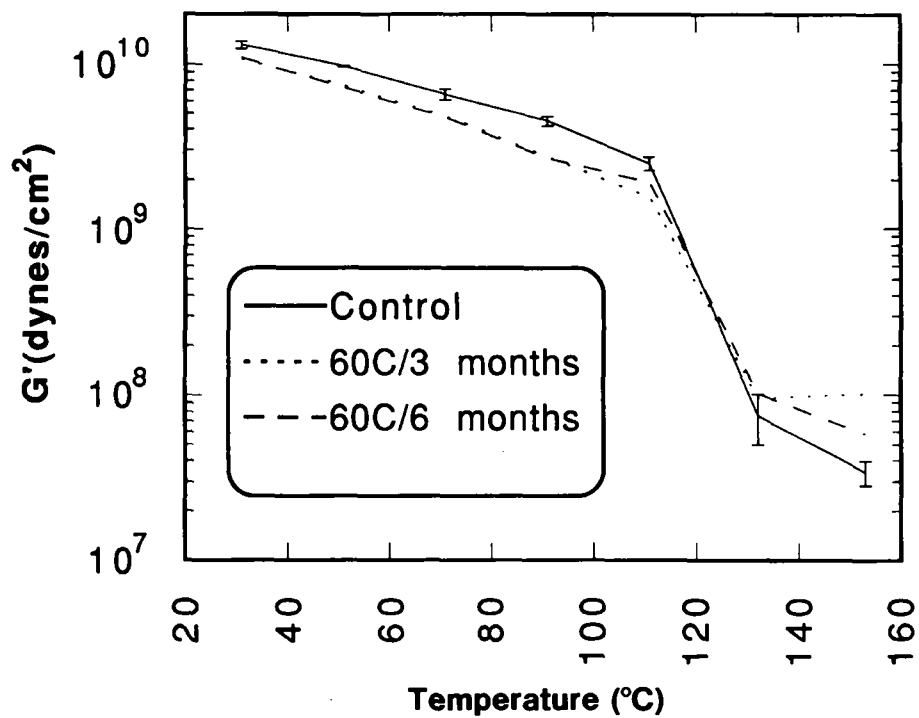
Figure 13. Storage modulus (G') vs. temperature of HDPE-1 after exposure times of 3 and 6 months at 60°C.

In a further effort to detect degradation of the electrodes, we monitored G' as a function of temperature from ambient to 150°C. The temperature range includes the melting transition of the polyethylene, which is 125°C. The data for HDPE-1 and -2 are shown in Figures 13 and 14, respectively. In the case of HDPE-1, a decrease in modulus was observed at temperatures below 120°C; above this temperature, the modulus was either the same or higher than that of the control. Somewhat differently shaped curves were obtained for HDPE-2. In this case, the moduli were either lower or the same as the control over the entire temperature range. The data above the melting transition are difficult to interpret in terms of degradation that might have occurred during aging and may be an artifact of the test.

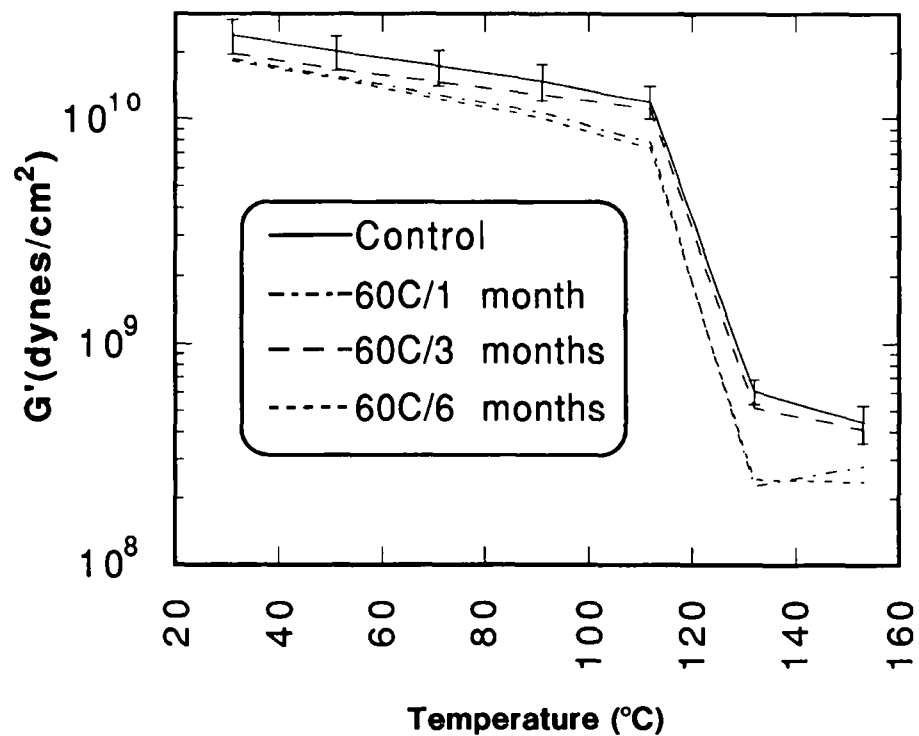
Figure 14. Storage modulus (G') vs. temperature of HDPE-2 after exposure times of 1, 3, and 6 months at 60°C.

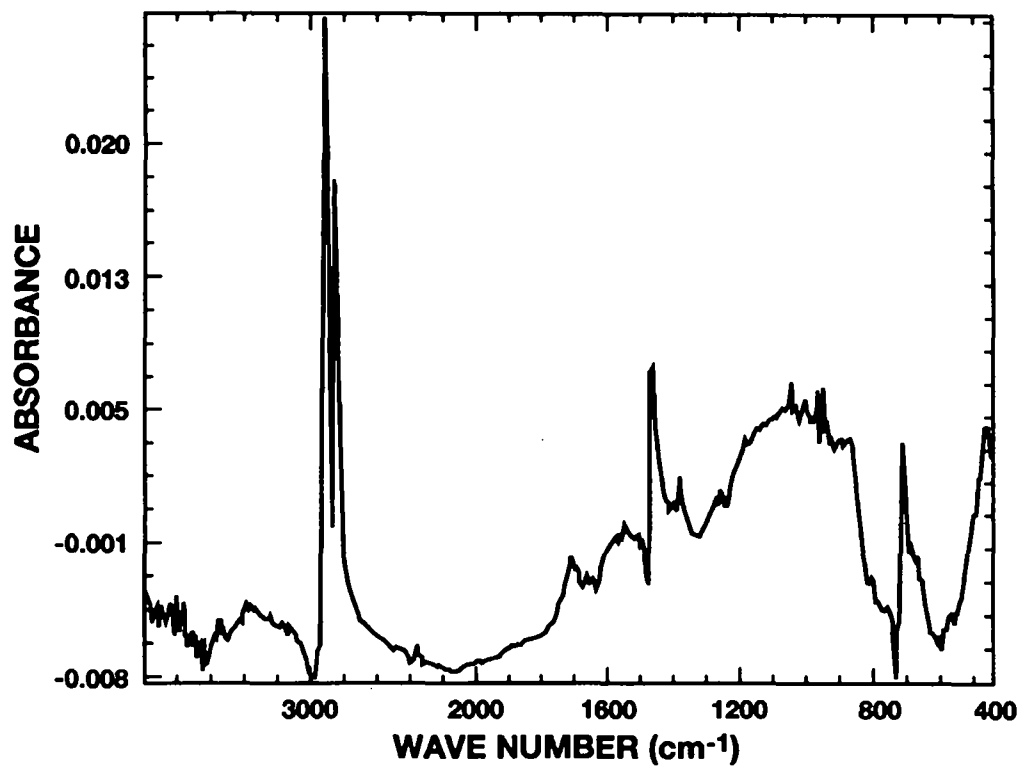
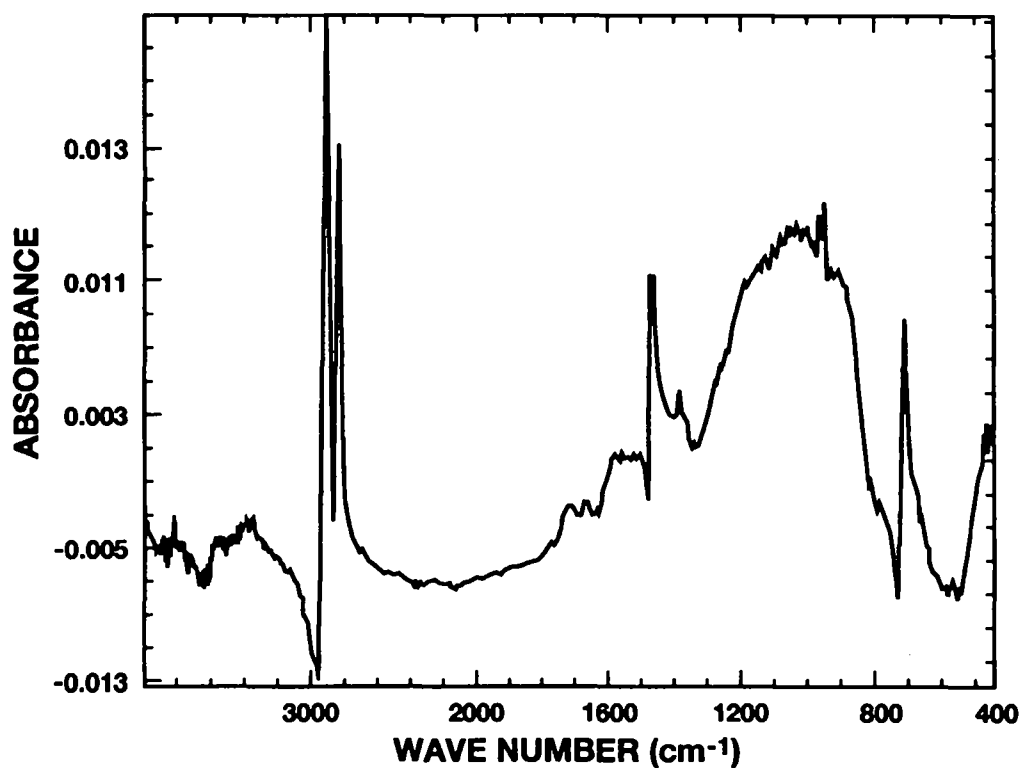
Figure 15. Fourier transform infrared spectra of HDPE-1. Upper spectrum, unaged; lower spectrum, after aging at 60°C for 6 months.

The upper curve of Figure 15 is an FTIR spectrum of *unaged* HDPE-1. The peaks at 2912, 2854, and 1465 cm^{-1} are attributable to the CH_2 group of the polyethylene. The small peak at 1710 cm^{-1} is at the frequency for carbonyl groups and is probably attributable to an antioxidant type of additive. One example of an additive having a carbonyl group and widely used as an antioxidant for polyolefins is dilauryl thioldipropionate.⁵ The broad absorption peak in the frequency range of 1100 to 800 cm^{-1} is attributable to the silicate groups of the glass fiber reinforcement. The "noise" in the spectrum at high frequencies is attributable to water vapor. The lower curve is the FTIR spectrum of a sample of HDPE-1 that had been aged in the electrolyte for 6 months at 50°C. Except for a difference in the intensity of the silicate group, the two spectra are virtually identical. One possible explanation for the difference in the silicate band intensity is that the glass fibers are not uniformly distributed in the electrode, and very small samples were used for analysis. Similar results were

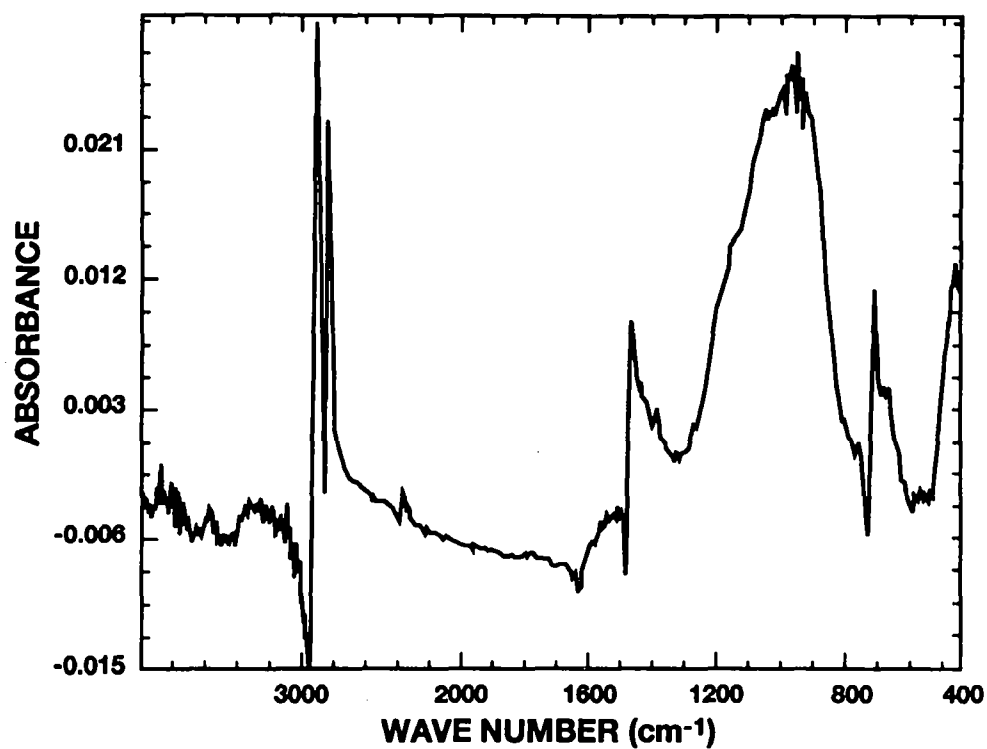
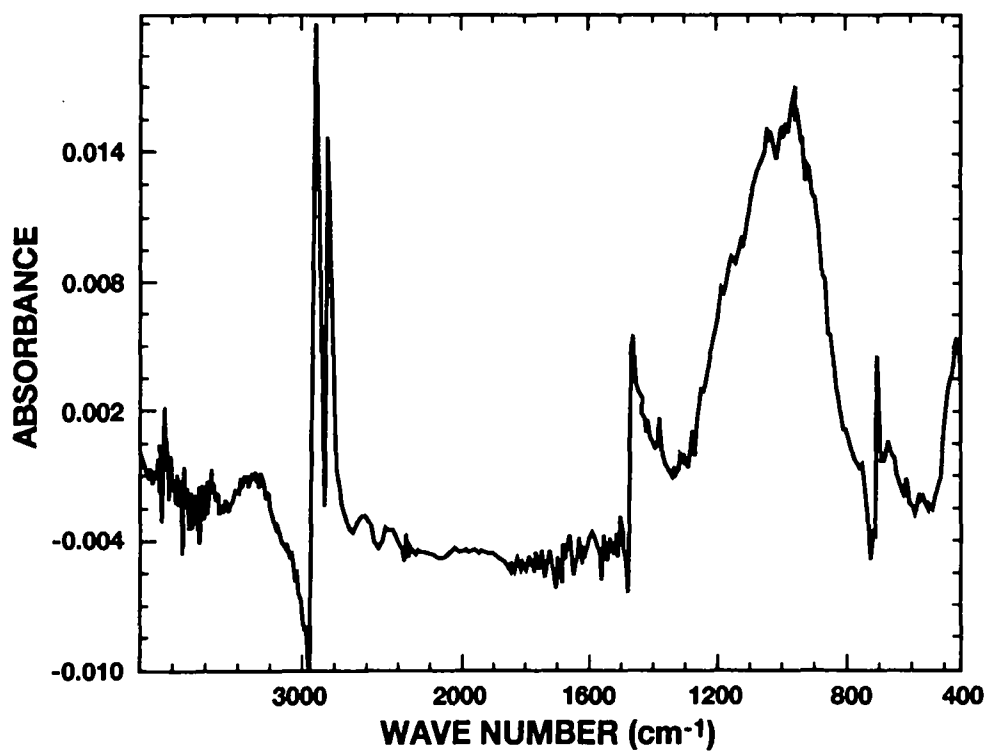
Figure 16. Fourier transform infrared spectra of HDPE-2. Upper spectrum, unaged; lower spectrum, after aging at 60°C for 6 months.

obtained for HDPE-2 (Figure 16) except that there was no carbonyl band in either the unaged or aged sample. These results indicate that oxidative degradation of HDPE-1 and -2 did not take place, and that the choice of HDPE as a replacement for the EP copolymers was justified. Furthermore, these results are consistent with the minimal changes observed in the thermal and mechanical properties of the electrodes that were discussed above.

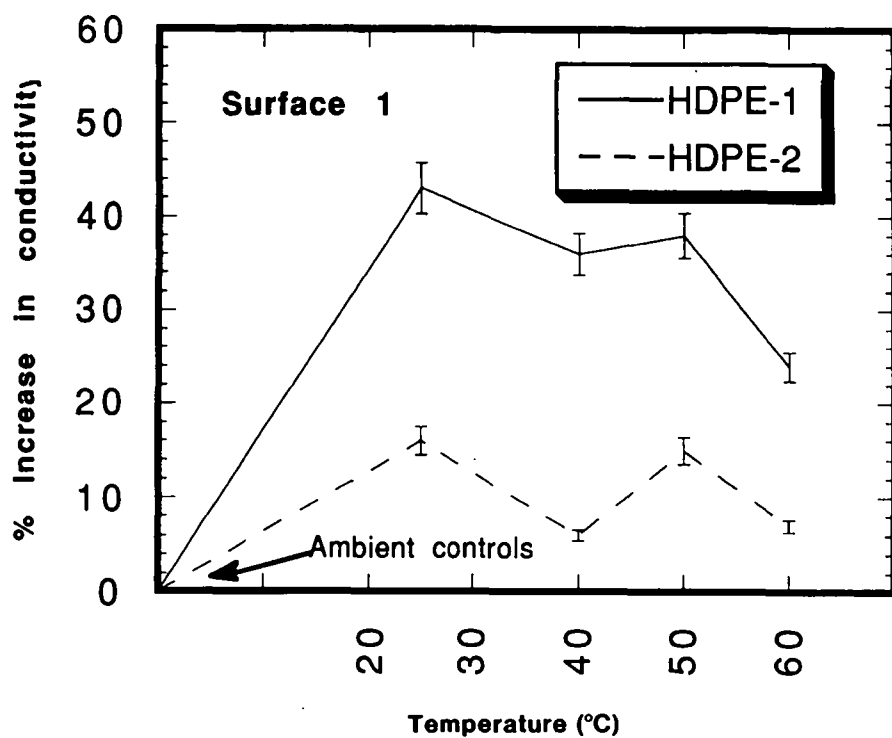
Figure 17. Percent increases of electrical conductivity on surface 1 of HDPE-1 and HDPE-2 after 6 months of aging as a function of temperature.

Electrical Conductivity. Data on changes incurred by aging on the electrical conductivity of HDPE-1 and HDPE-2 for 6 months at various temperatures are shown in Figures 17 and 18. To determine if there was any difference between opposite surfaces of the electrodes, data were collected on both surfaces. These surfaces were arbitrarily designated as surface 1 (Figure 17) and surface 2 (Figure 18). Each data point represents an average of four measurements. It is evident that aging increased the conductivity of the electrodes. This of course is very desirable. Conductivity increases ranged from 5% to 48% and were higher for HDPE-1 than for HDPE-2. The higher increase observed for HDPE-1 may be because this electrode has a higher carbon-plastic content and sorbs greater amounts of the electrolyte. The highest increases in conductivity were observed for samples aged at ambient conditions. This observation may be attributed to the fact that these samples had been agitated during aging to ensure good contact with the two-phase electrolyte. Generally, it is believed that the increase in conductivity is due to good wetting of the electrodes by the electrolyte.

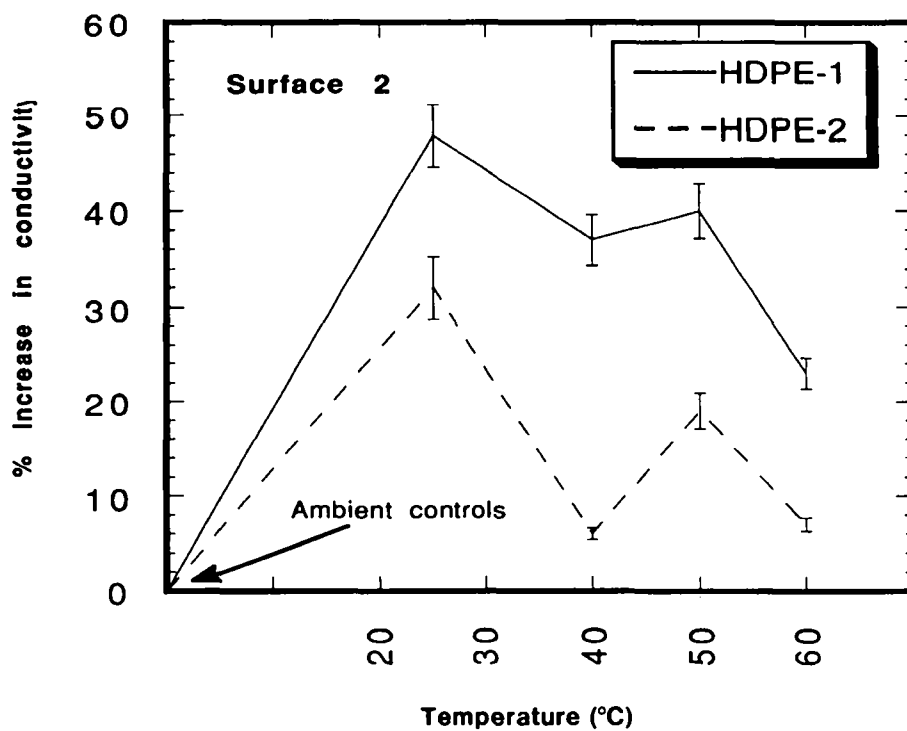
Figure 18. Percent increases of electrical conductivity on surface 2 of HDPE-1 and HDPE-2 after 6 months of aging as a function of temperature.
